Hazel McCallion Campus Phase 2A Addition C Wing

Site Progress Photos as of September 27th,
2019

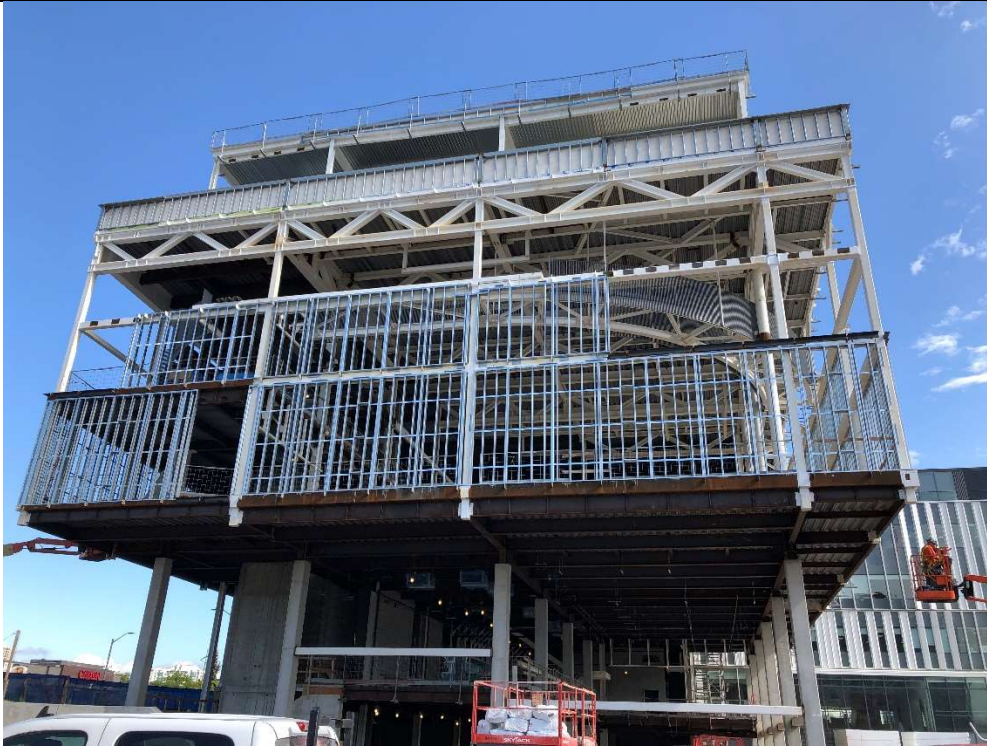
Photo taken
looking
Northeast
towards B-Wing.
Level 5
structural slab
has been
poured. Exterior
perimeter metal
stud progressing
to the fourth
Mezz. level.
While masonry
work has begun
within the
interior.

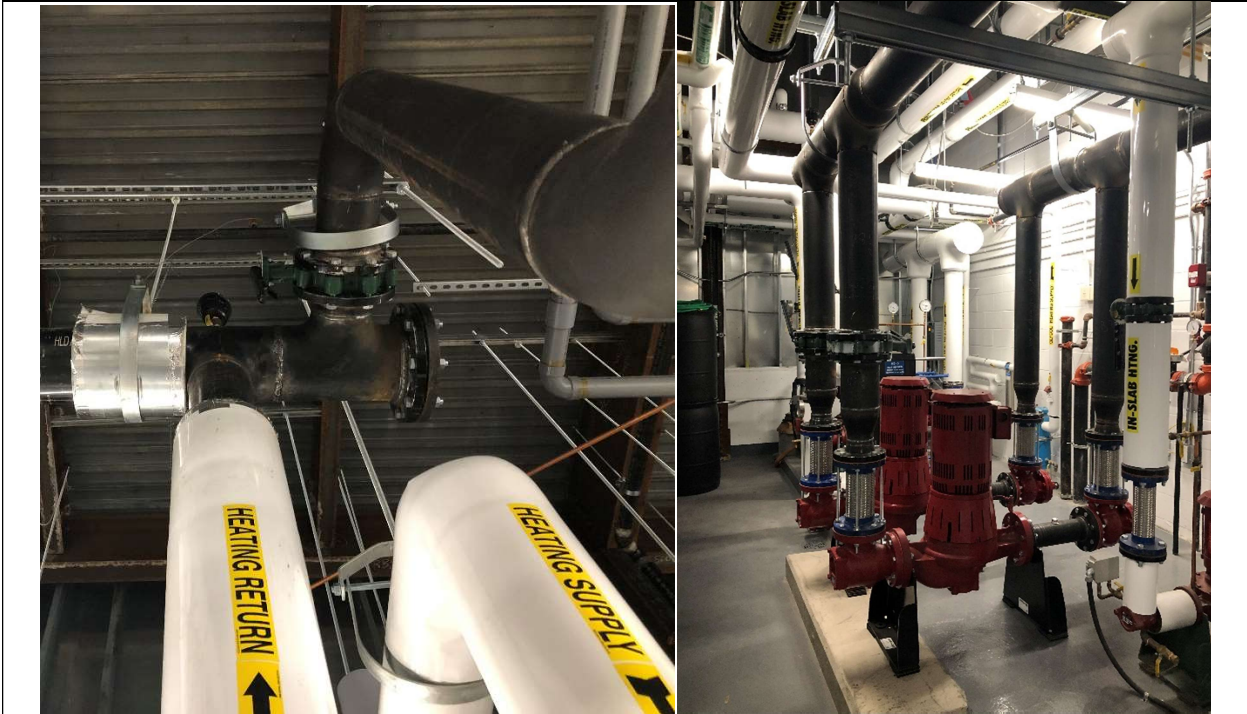
Right Photo – Installation of pumps along with associated piping within the B-Wing Penthouse Boiler room.

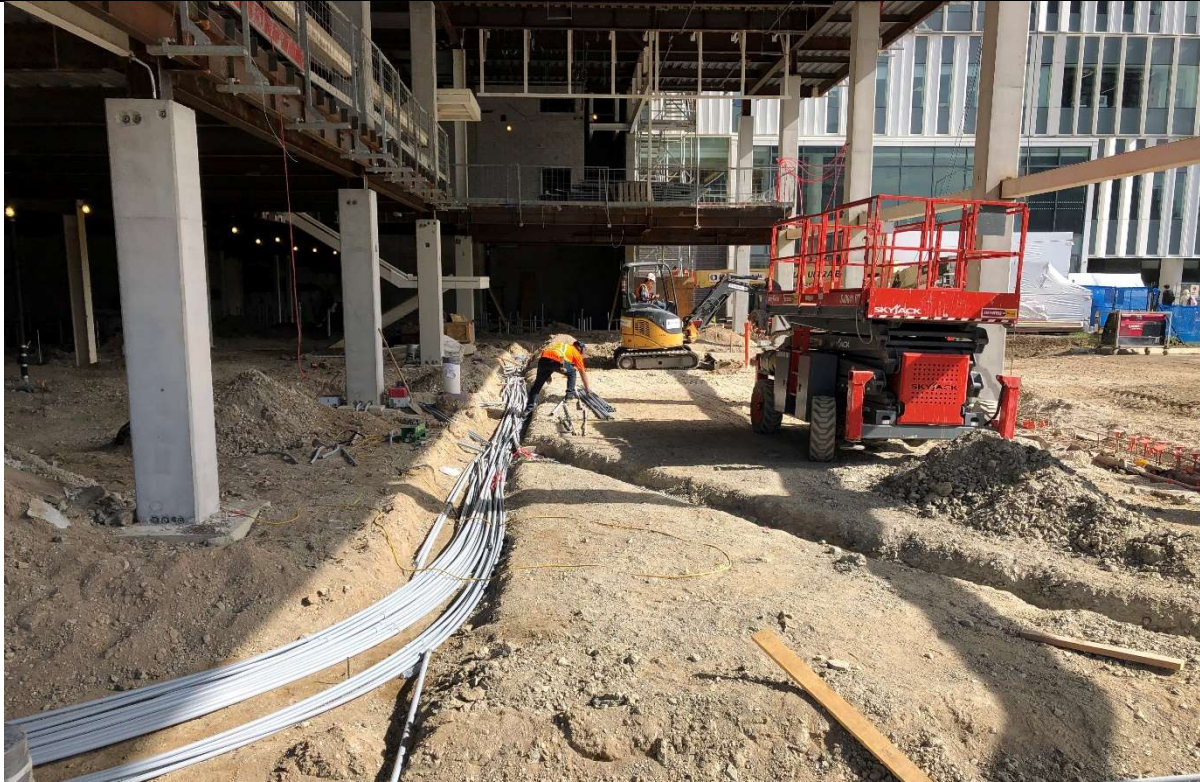
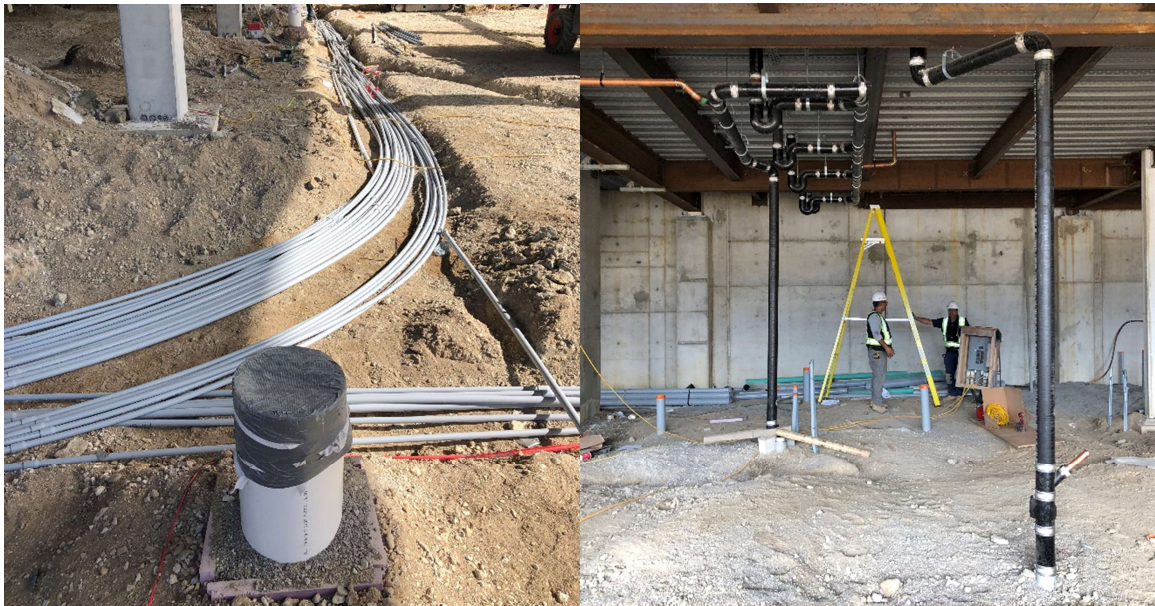
Installation of electrical and AV under slab conduits continues at level 1, along with the installation of the AV under slab pathway for productions. Mechanical plumbing work within the ceiling space has begun within the kitchen C112b and washrooms C117/116.

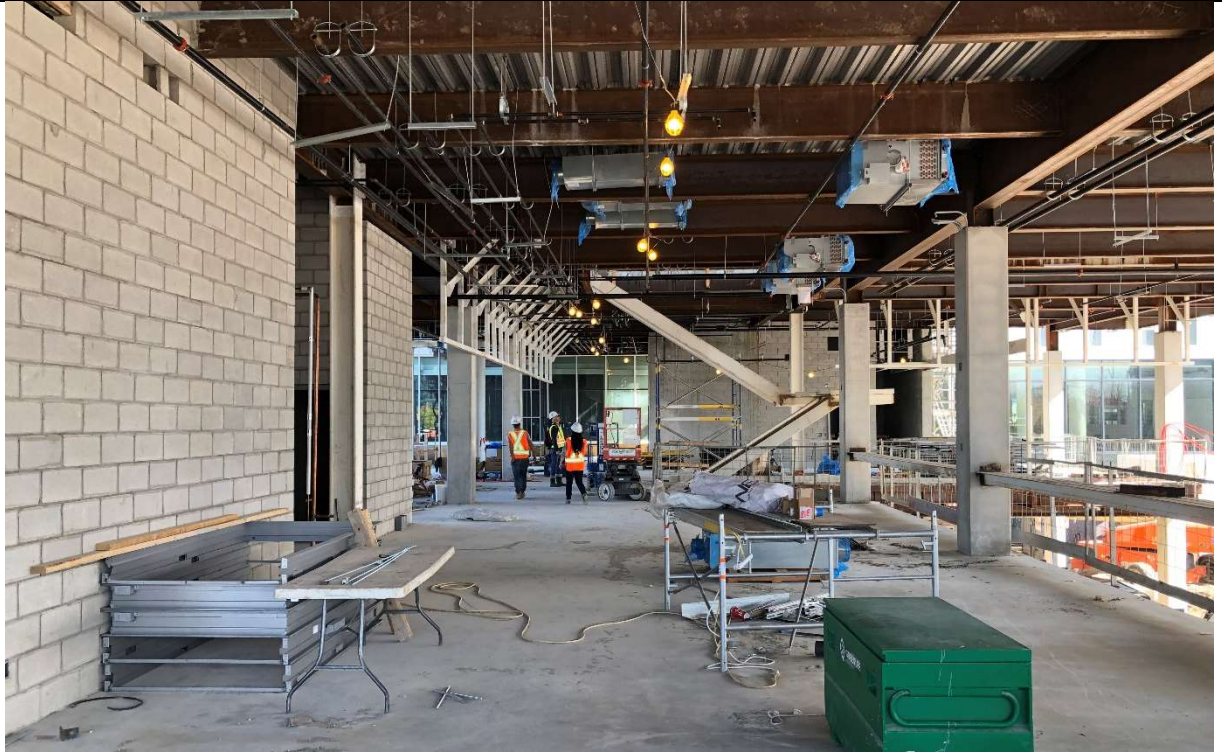
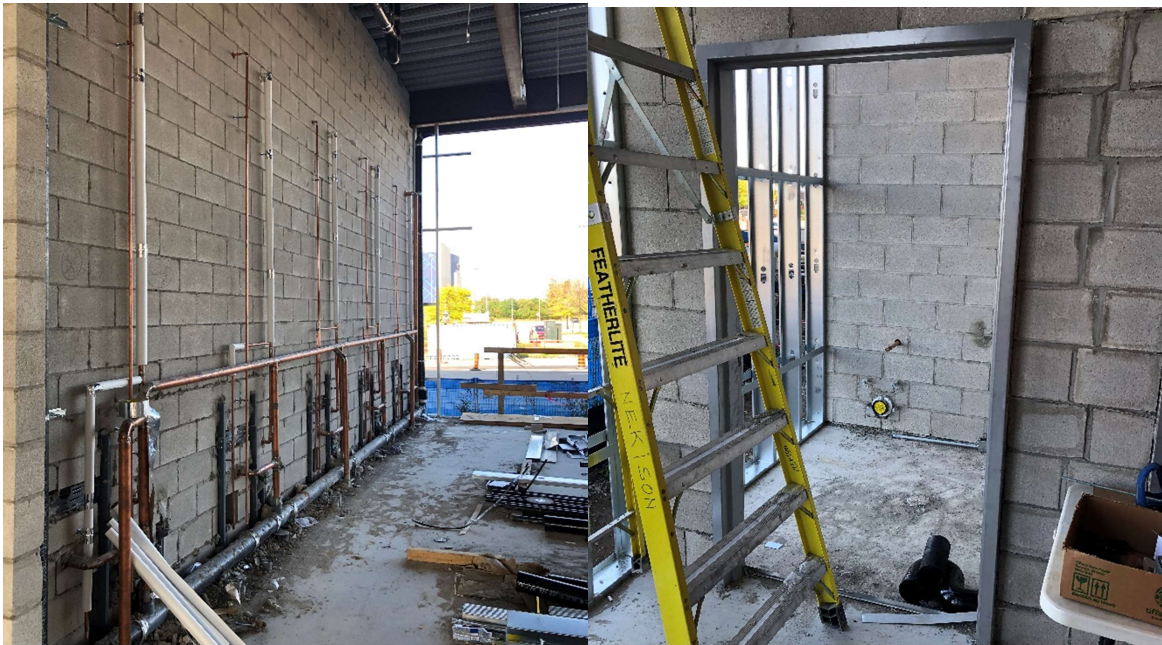
Masonry interior partitions at Level 2 are completed along with with all associated mechanical plumbing and electrical rough-ins. Installation of ceiling mounted HVAC equipment has begun starting with fancoils and VAV boxes in C203 Common Lounge.

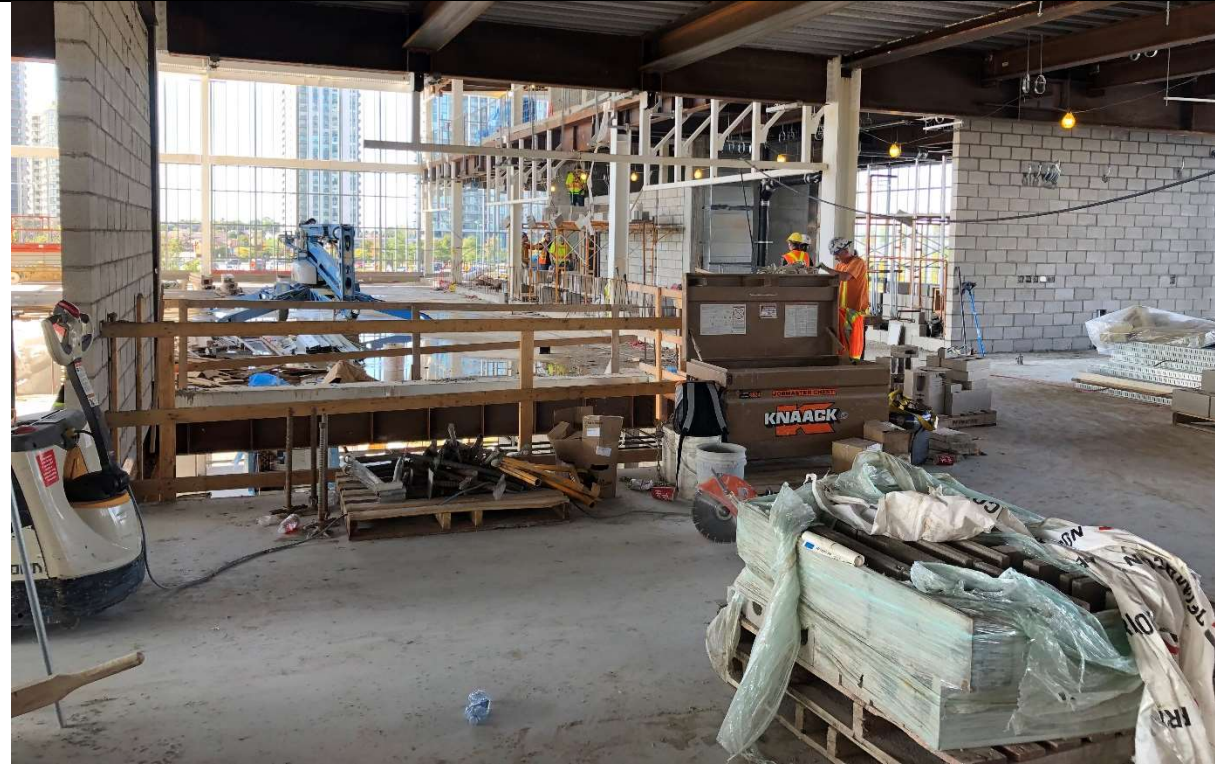
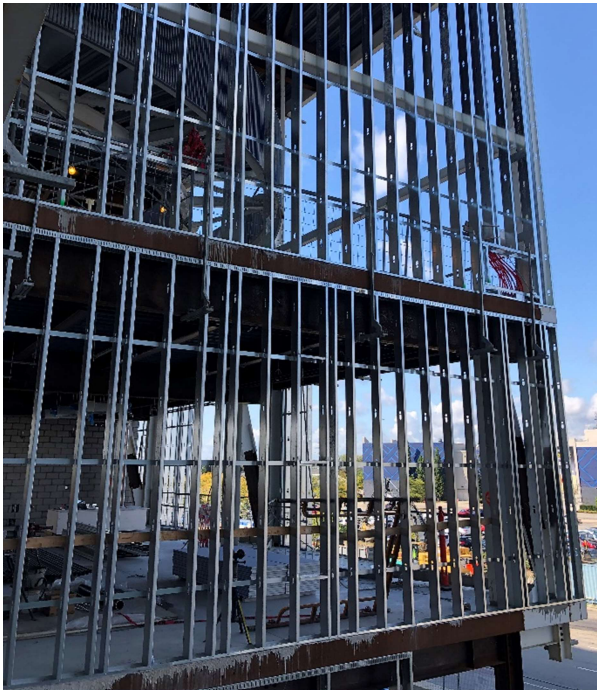
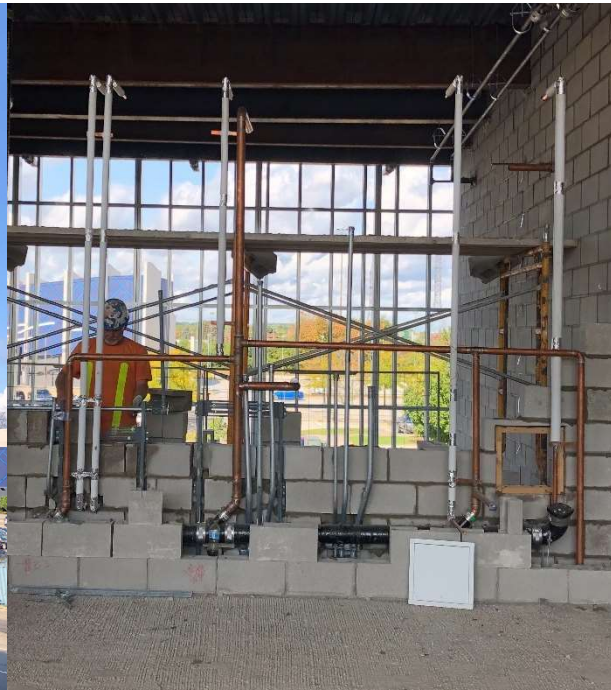
Interior masonry partitions currently being installed on Level 3 along with all mechanical and electrical rough-ins. Perimeter metal studs currently being erected at the Northeast entrance. Curtain wall has begun installation along the north façade of the building starting with room C303 Lounge Games.

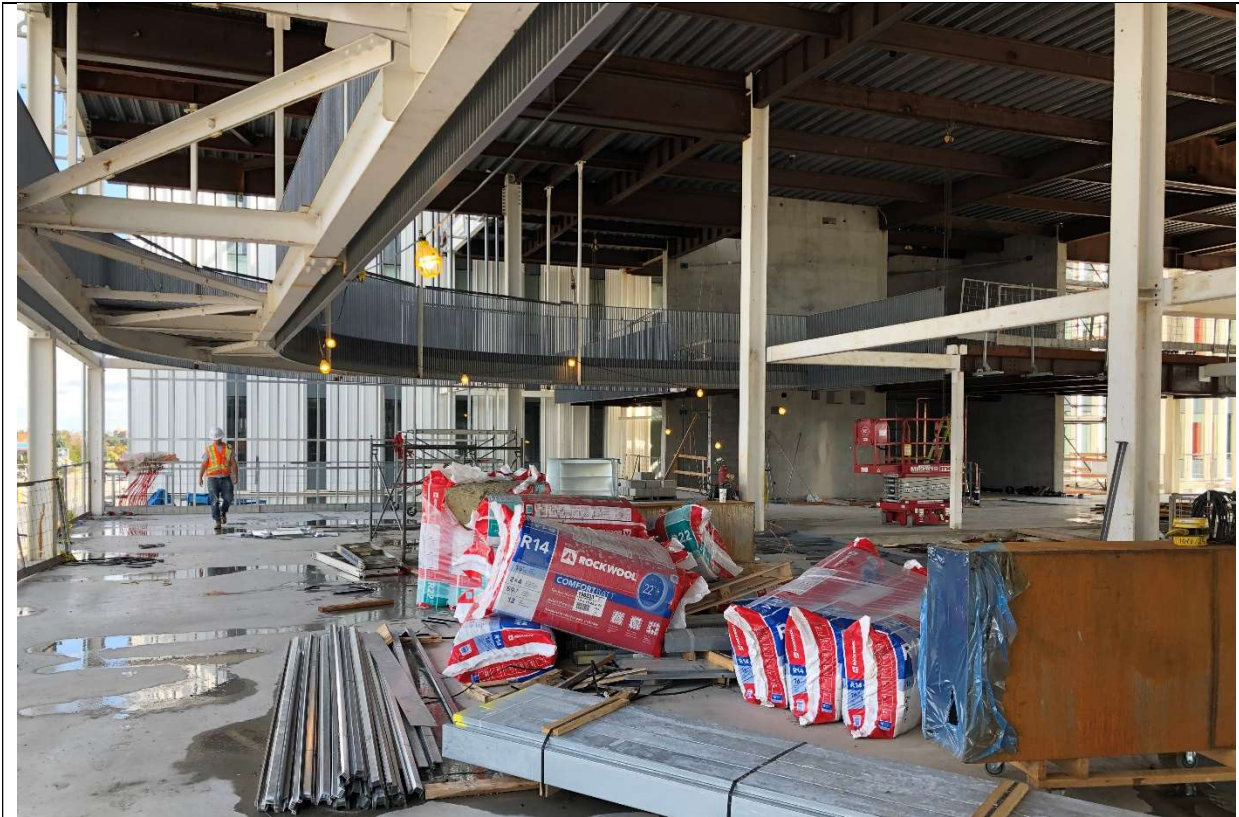
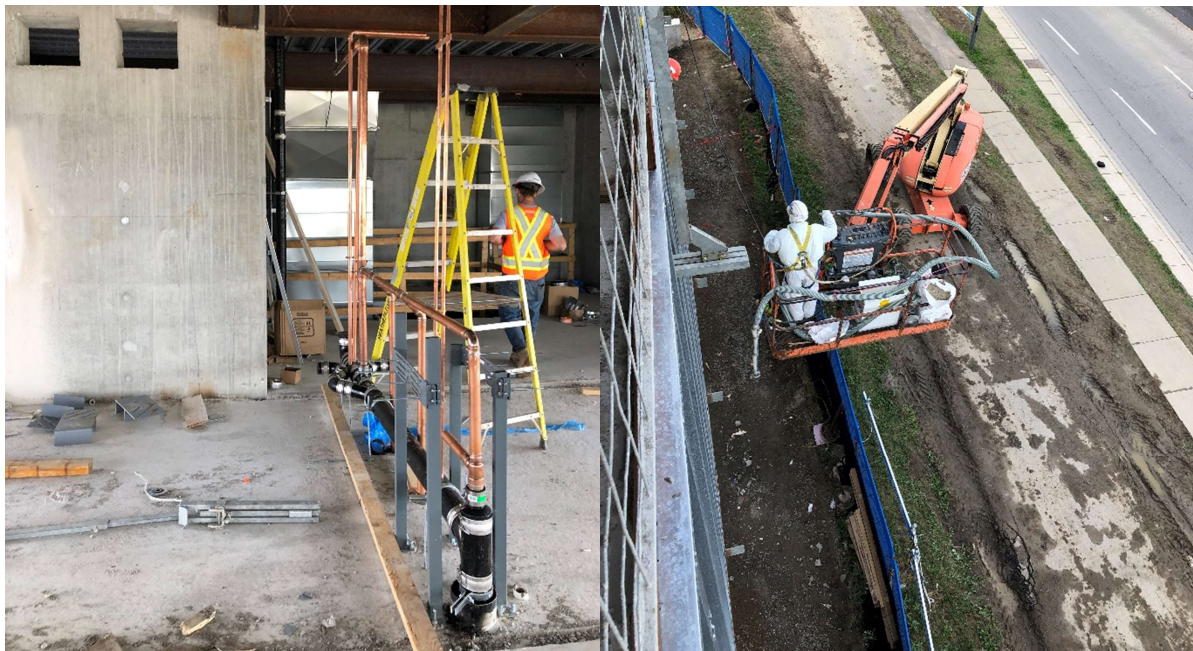
Level 4 misc. metal guards installation nearing completion. Mechanical rough ins have begun within masonry partitions. Sprayed applied fire proofing is progressing along the north façade.

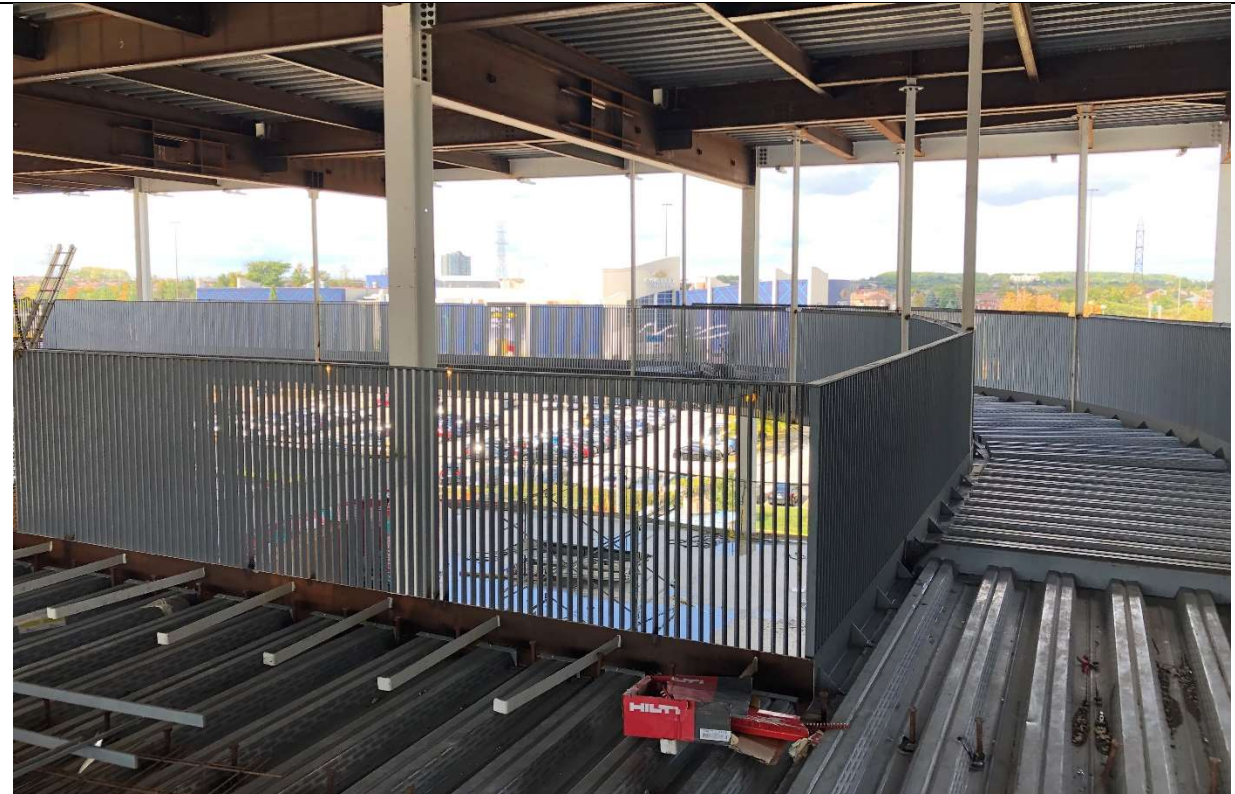
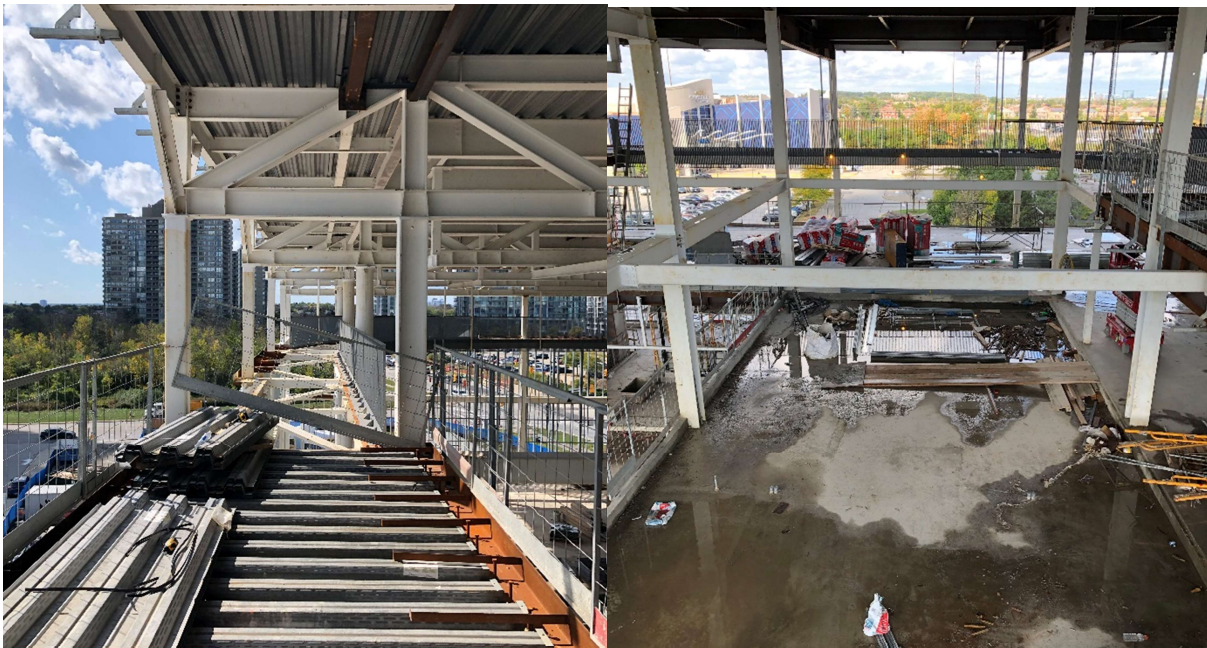
Level 4 Mezzanine, track guard installation nearing completion, with metal decking flowing closely behind. Once decking has been completed the surface will be prepped for the structural concrete pour.

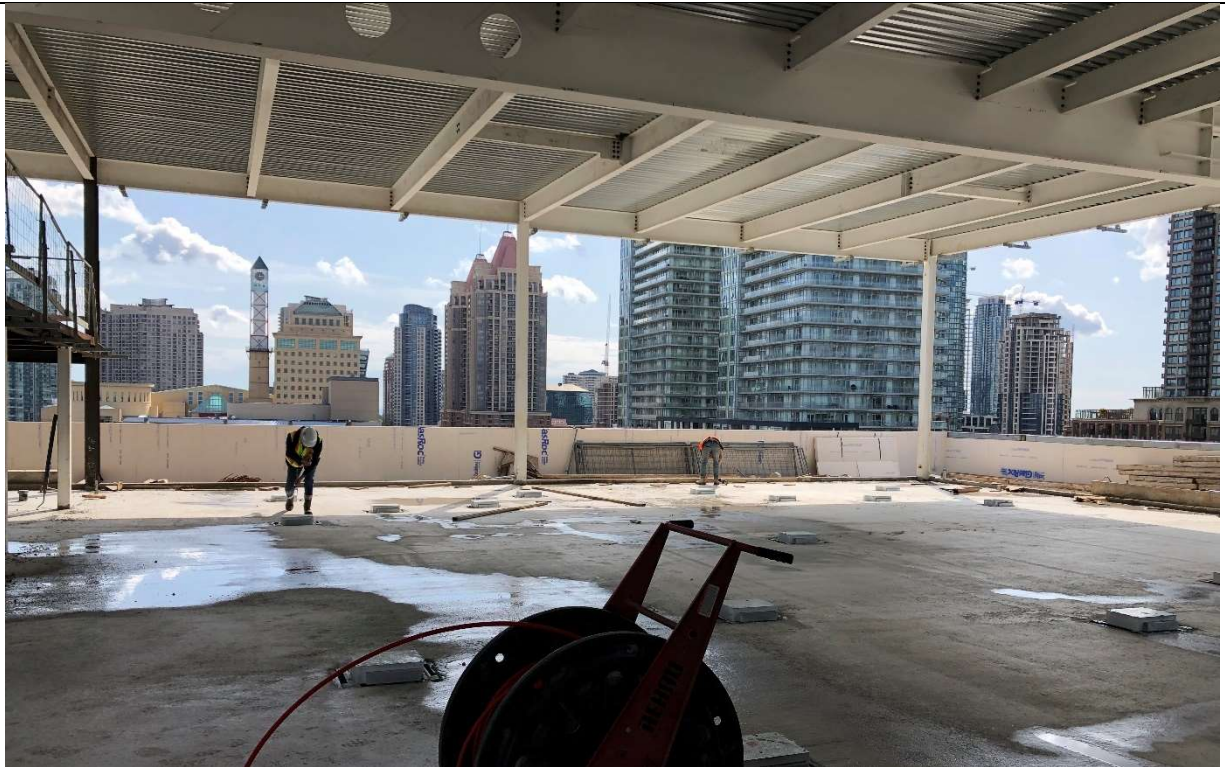
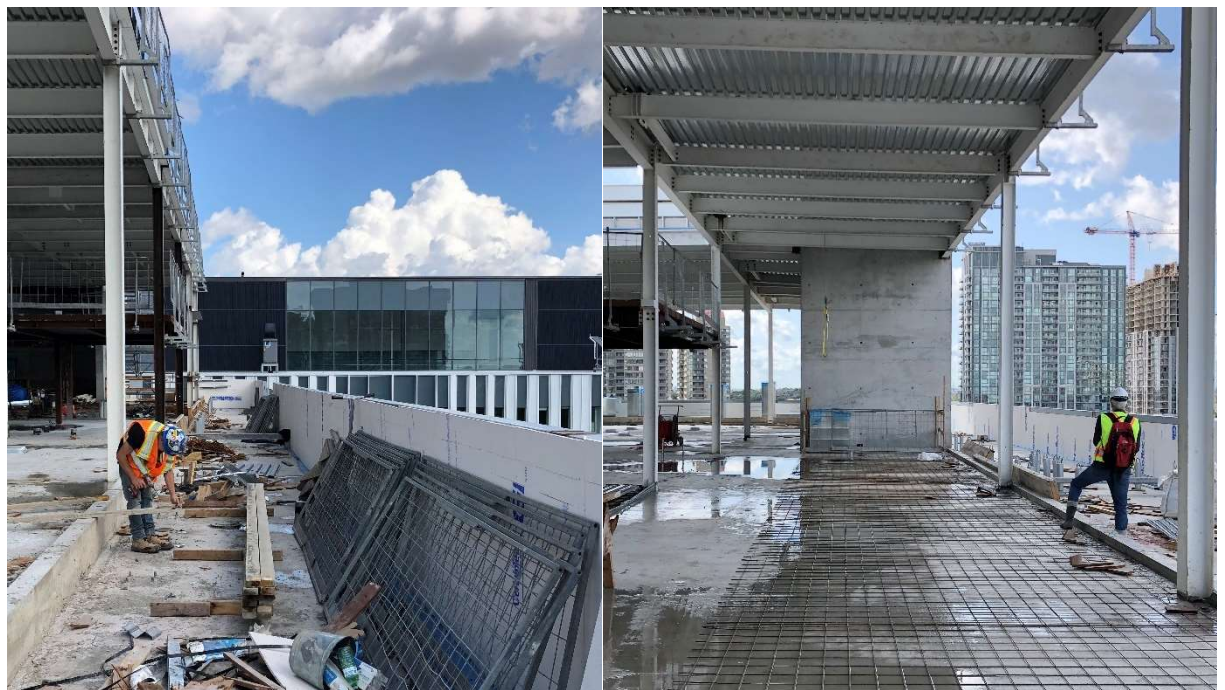
Level 5 structural slab has been poured with mesh currently being laid, concrete topping to be poured Friday October 4th. Perimeter terraces have been boarded with GlasRoc.

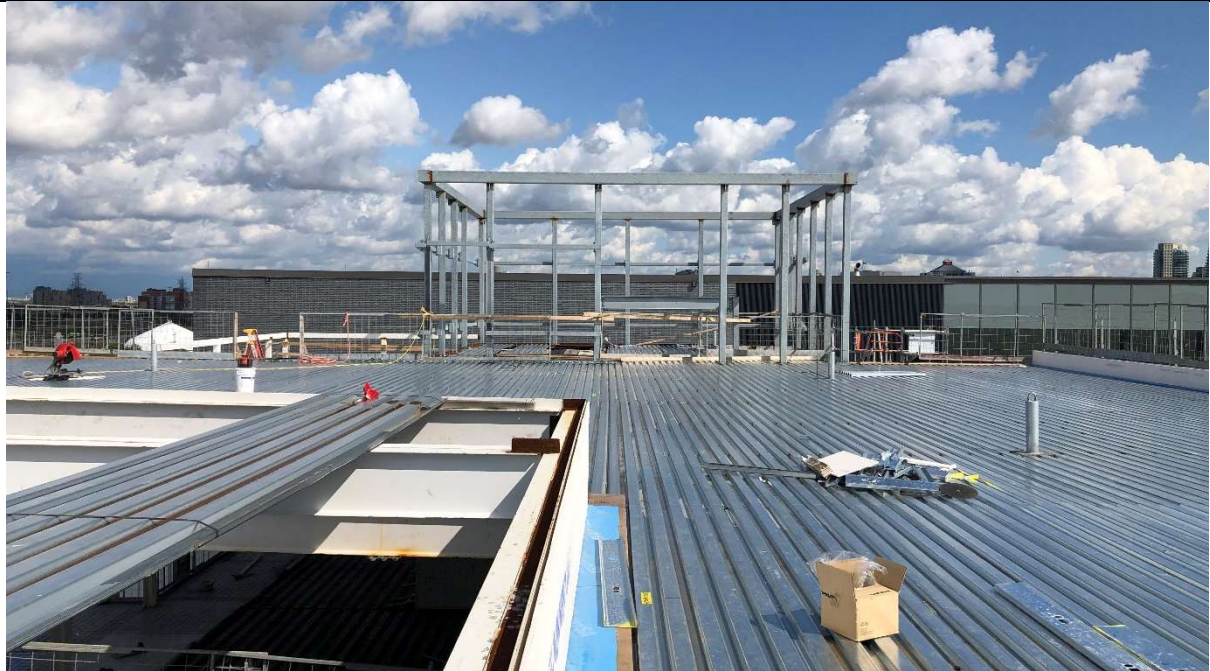
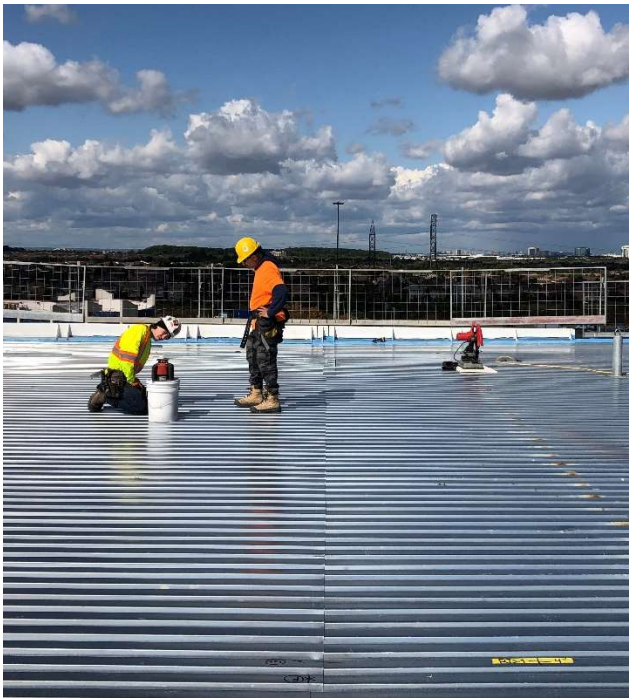
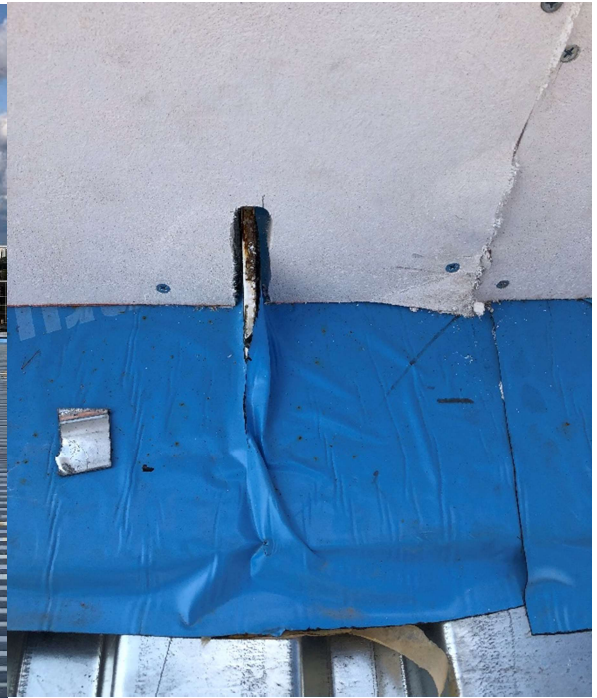
Roof Level – work continues at the perimeter parapet wall and deck sleeving, roofing starting with Dens Deck and vapour barrier to begin shortly.
